## Canusa Repair for PE & PU Main Line Coatings

## Pipeline Repair Products

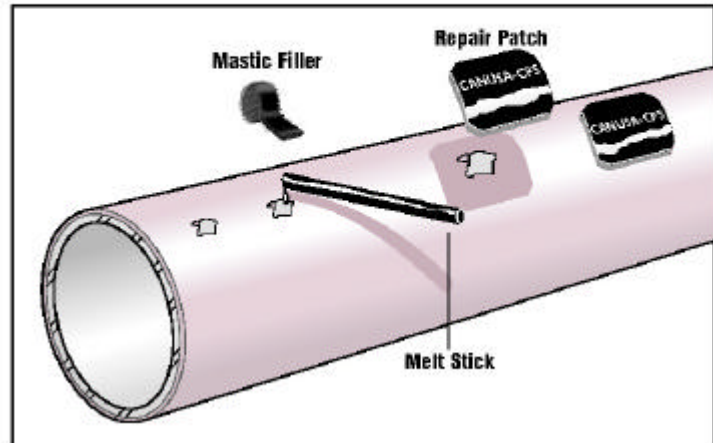
Mainline coating repair products for corrosion protection

Score around the damaged area with a Stanley knife, removing angular edges.

Use a wire brush to rough the surface and thoroughly clean the area and degrease. Gently heat the area to 60°C and infill the damaged area with a melt stick or mastic filler and then apply the repair patch.

If the damage is superficial, i.e. a cut or scuff that is not through to the steel, the melt stick application is sufficient. If the damage is deeper, apply a Canusa Patch to the area by heating the mastic side and placing it over the filled, damaged area. Continue to apply heat, and roll / pat down the patch until all air bubbles are out and adhesive can be seen around the edges of the patch.
